SHORT REPORT – NO VISIBLE IMPACT

Activation number: EMSR480

AOI name: AOI 09 Kolymvari

Product Type: GRADING

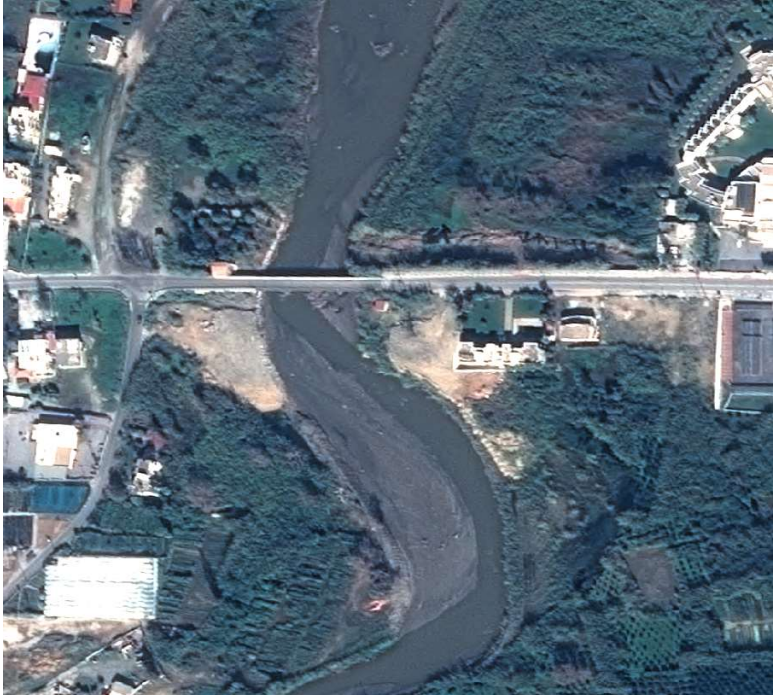
Post-event situation In the image acquired on 15/11/2020, no damages to infrastructure are visible. Even roads and bridges besides the river seem to be unaffected.
Result of analysis	The image quality has been assessed as appropriate for the GRADING analysis. In the covered area, no visible damages have been identified.	
Methodology used	Photo-interpretation.	
Additional comments	A small part of around 30ha is not visible in both post event images due to cloud coverage.

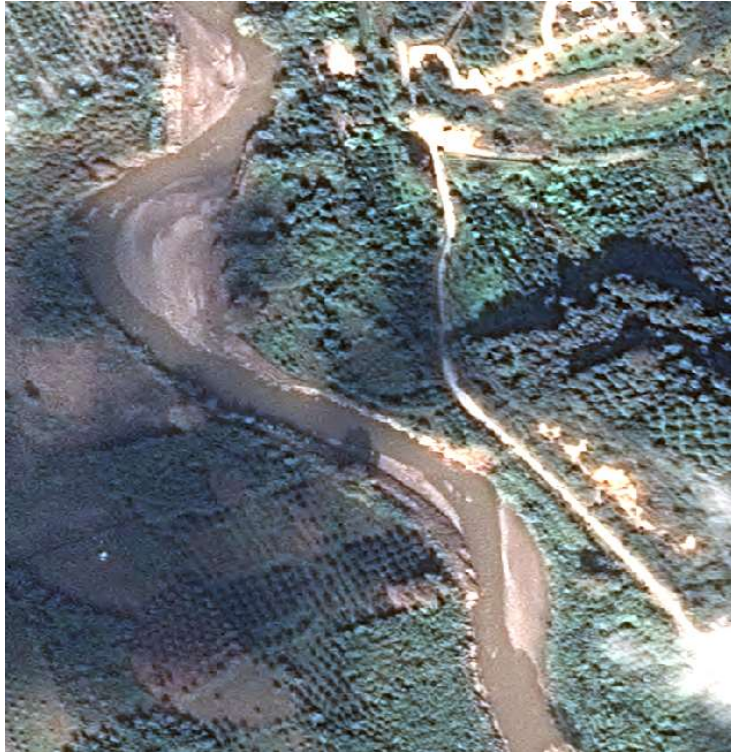
Post-event situation In the image acquired 15/11/2020, some riverbanks are eroded but infrastructure or agricultural fields seem not to be affected.
	Result of analysis	The image quality has been assessed as appropriate for the GRADING analysis. In the covered area, no visible damages have been identified.
	Methodology used	Photo-interpretation.
	Additional comments	The analyzed images fully covers the AOI.

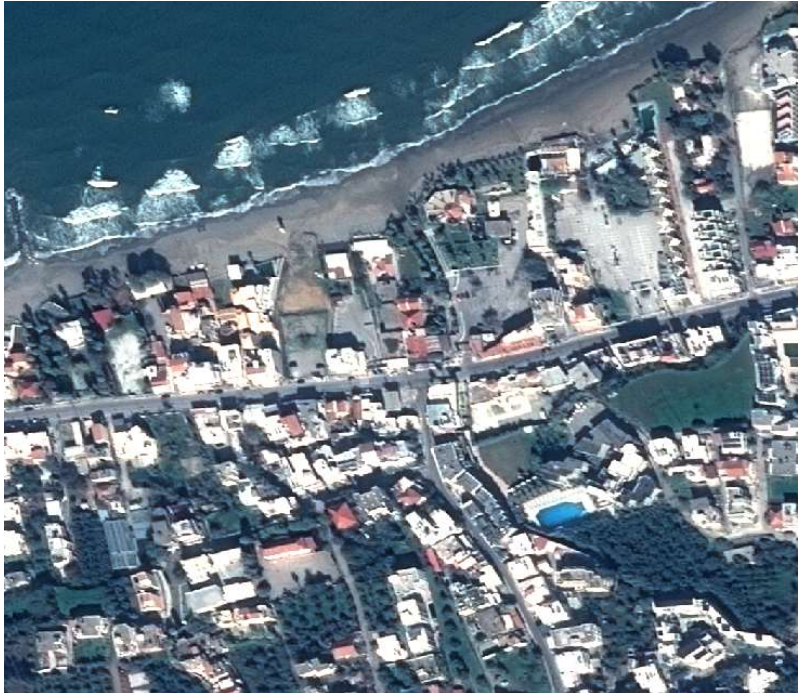
<p>Post-event situation In the image acquired 15/11/2020, no damages to buildings can be detected.</p>
Result of analysis	The image quality has been assessed as appropriate for the GRADING analysis. In the covered area, no visible damages have been identified.	
Methodology used	Photo-interpretation.	
Additional comments	The analyzed images fully covers the AOI.
