SHORT REPORT – NO VISIBLE IMPACT

Activation number: EMSR480

AOI name: AOI 09 Kolymvari

Product Type: GRADING

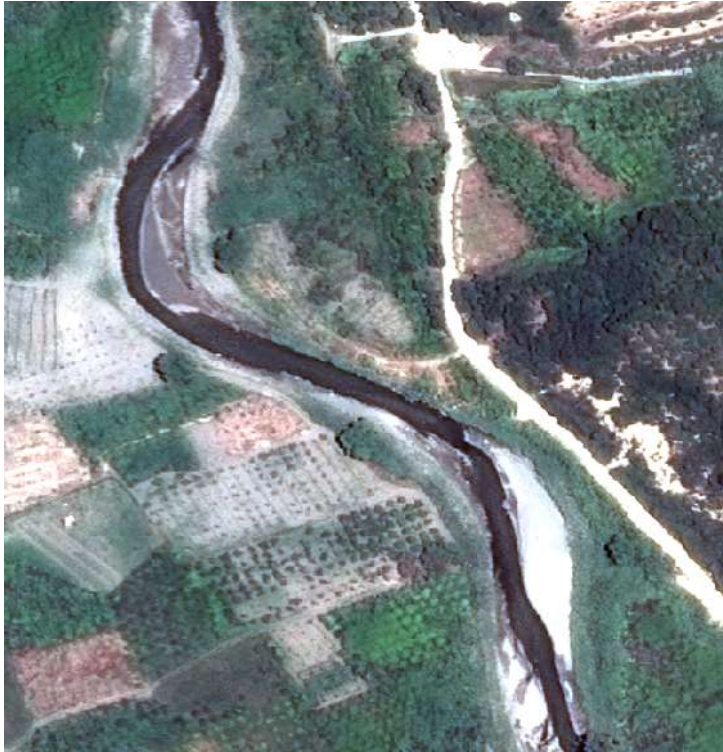
Post-event situation In the image acquired 15/11/2020, some riverbanks are eroded but infrastructure or agricultural fields seem not to be affected.
	Result of analysis	The image quality has been assessed as appropriate for the GRADING analysis. In the covered area, no visible damages have been identified.
	Methodology used	Photo-interpretation.
	Additional comments	The analyzed images fully covers the AOI.

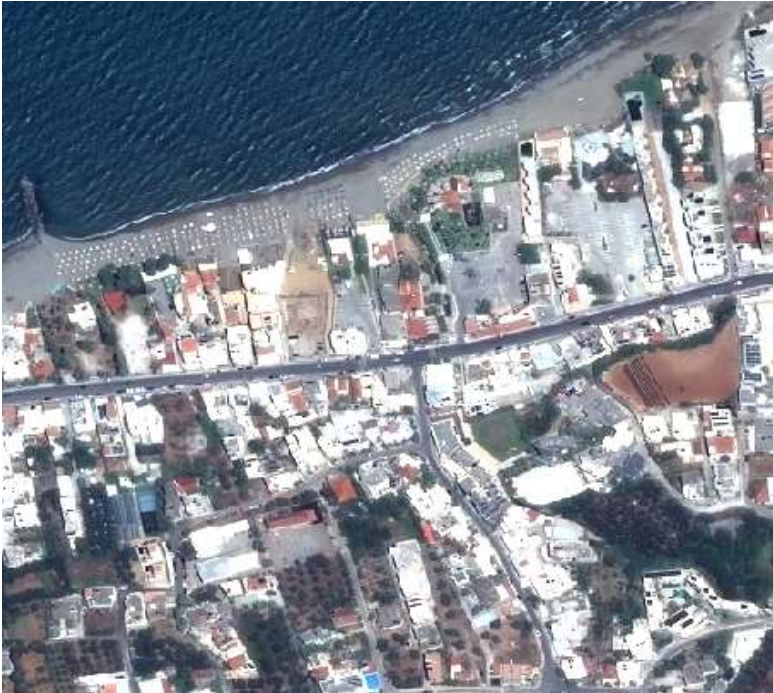
<p>Post-event situation In the image acquired 15/11/2020, no damages to buildings can be detected.</p>
Result of analysis	The image quality has been assessed as appropriate for the GRADING analysis. In the covered area, no visible damages have been identified.	
Methodology used	Photo-interpretation.	
Additional comments	The analyzed images fully covers the AOI.
